NATIONAL BUREAU OF STANDARDS REPORT

AN INVESTIGATION ON THE FIRE SPREAD POTENTIAL OF PLASTIC PIPE INSTALLATIONS

10 342

I. A. Benjamin and W. J. Parker

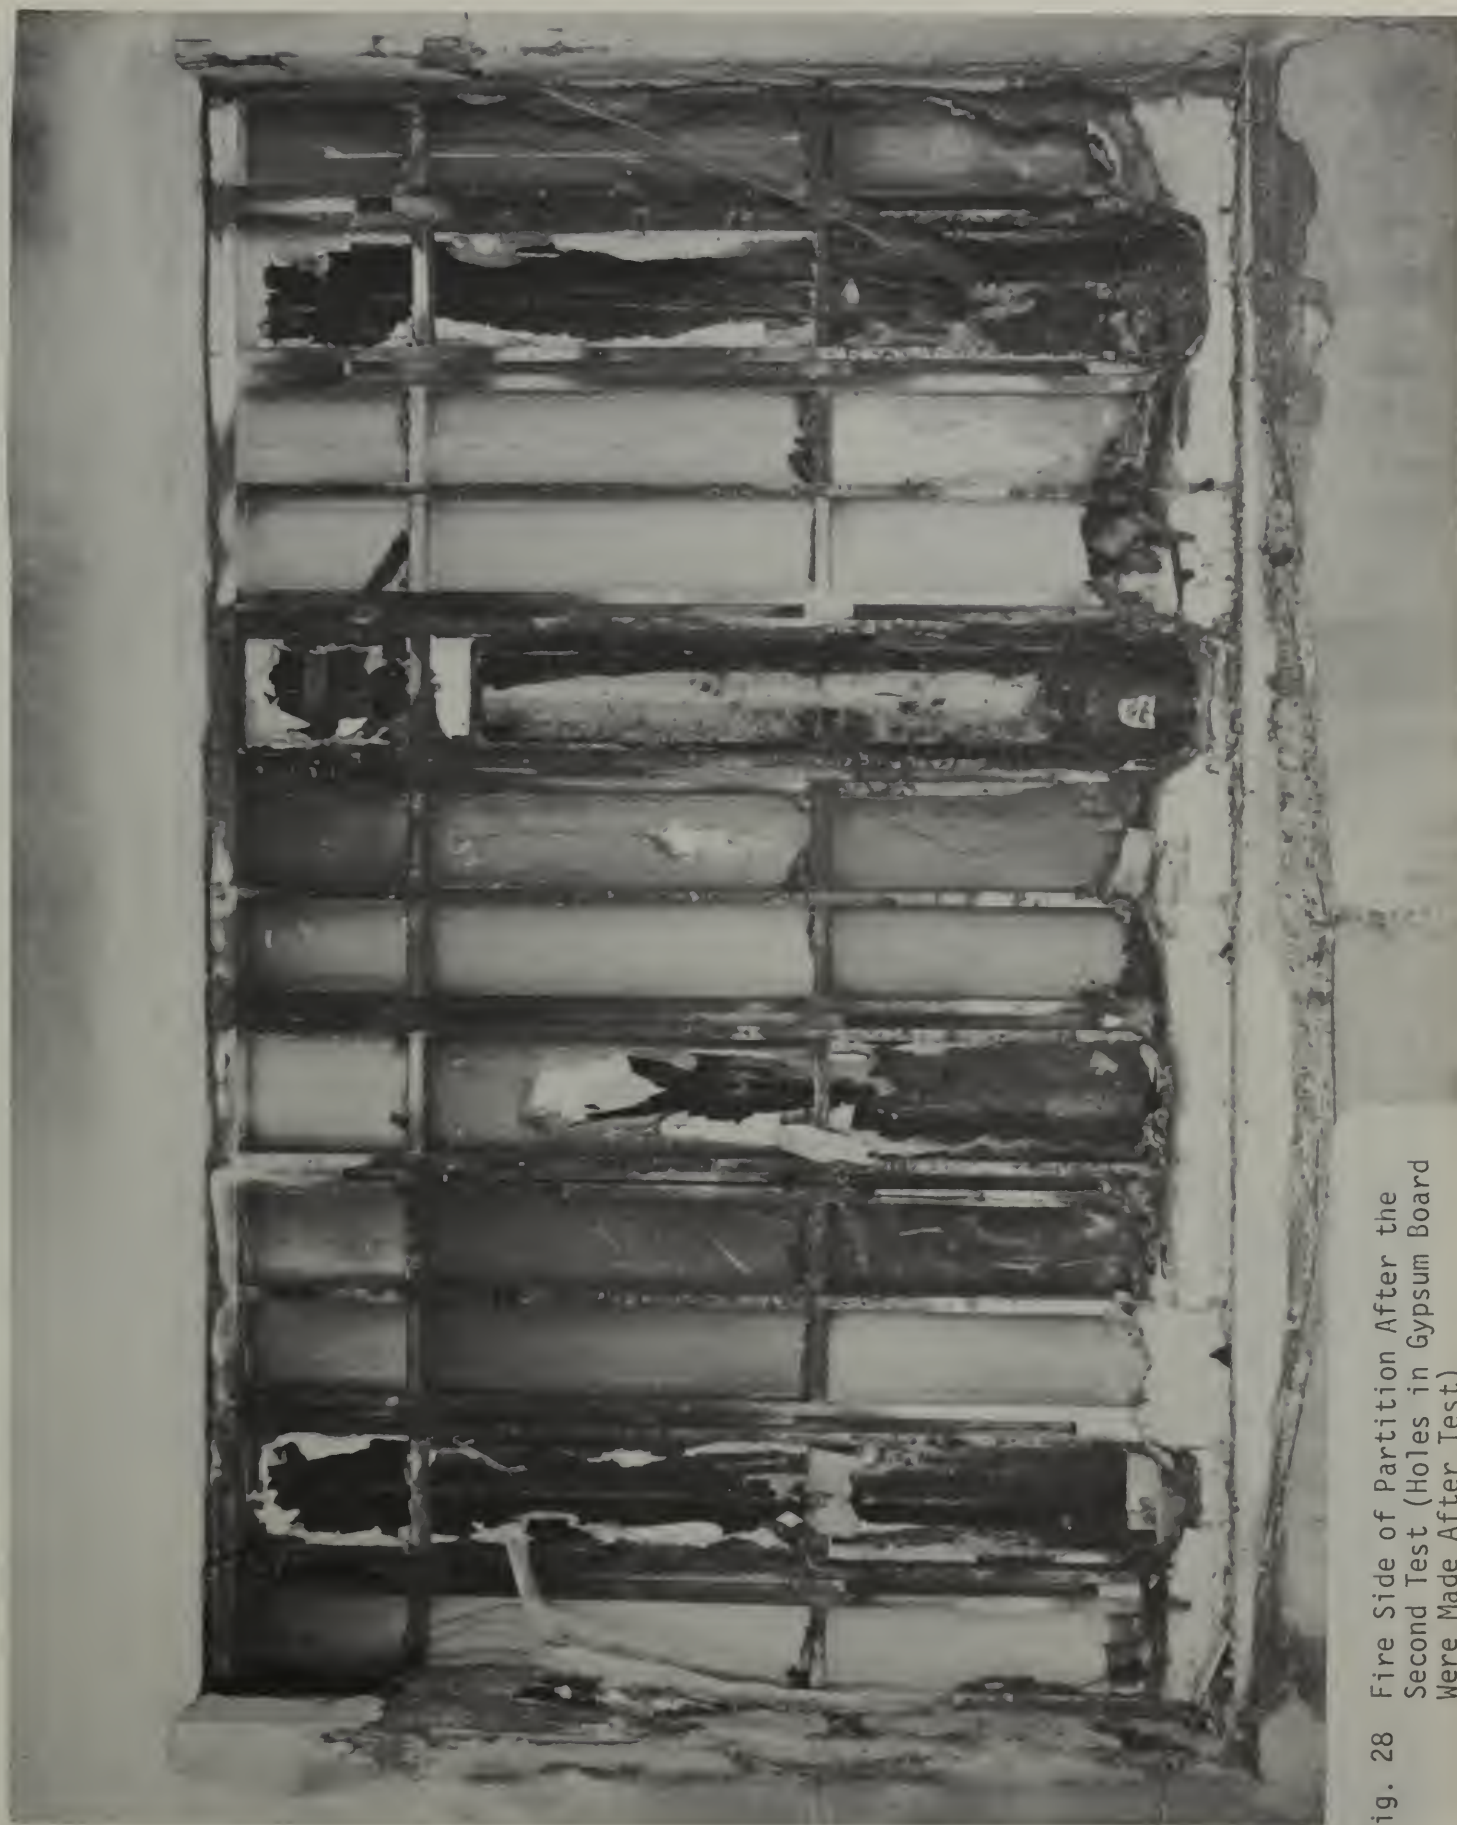
Fig. 28 Fire Side of Partition After the
Second Test (Holes in Gypsum Board
Were Made After Test)

Figure 28 shows the wood stud framing after the second test with the exposed gypsum board removed. The chases are 8, 5, 7, and 6 starting at the left. The charring of the studs not associated with the chases is minimal and the amount of charring or burning of the studs associated with the chases is in proportion to the interior damage in the chase. The fire stop and the lower portions of the studs burned out completely in chase 7, as seen in figure 29, resulting in moderate involvement of the upper framing of this chase as shown in figure 30. The gypsum board in the interior of the chases was intact in chases 5 and 8, (the chases with the steel sleeve on the lateral) 20% destroyed in chase 6 and 100% destroyed in chase 7.

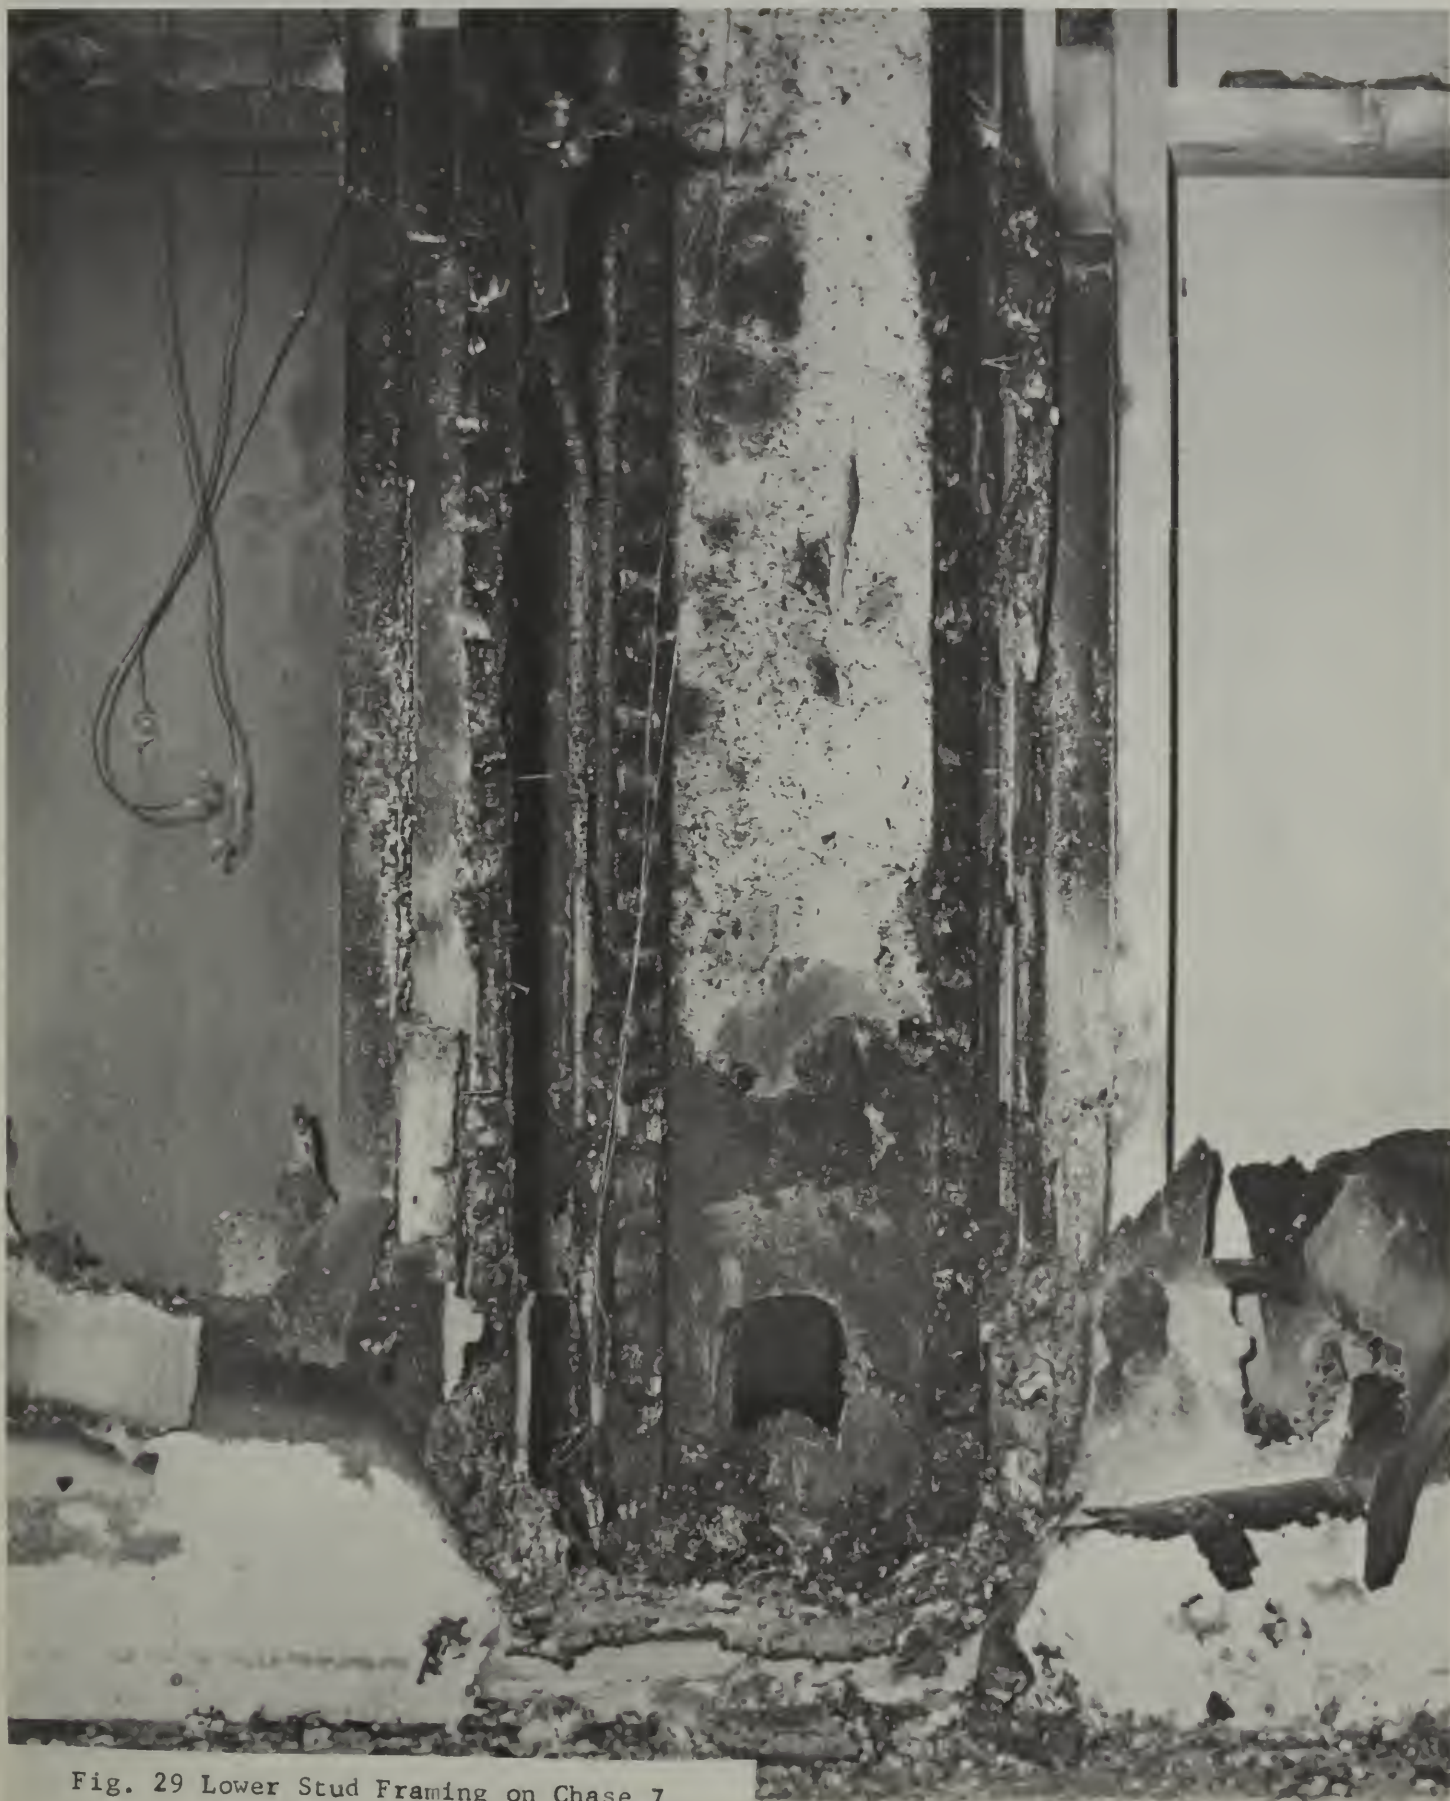
Fig. 29 Lower Stud Framing on Chase 7
After Test

The most severe damage occurred in the chase with the double 45° wye and the ABS lateral without the steel sleeve. The plastic pipe was completely burned out, the studs were actively burning prior to the end of the test, and the ignition temperature of ABS was exceeded at the level of the upper 45° wye.

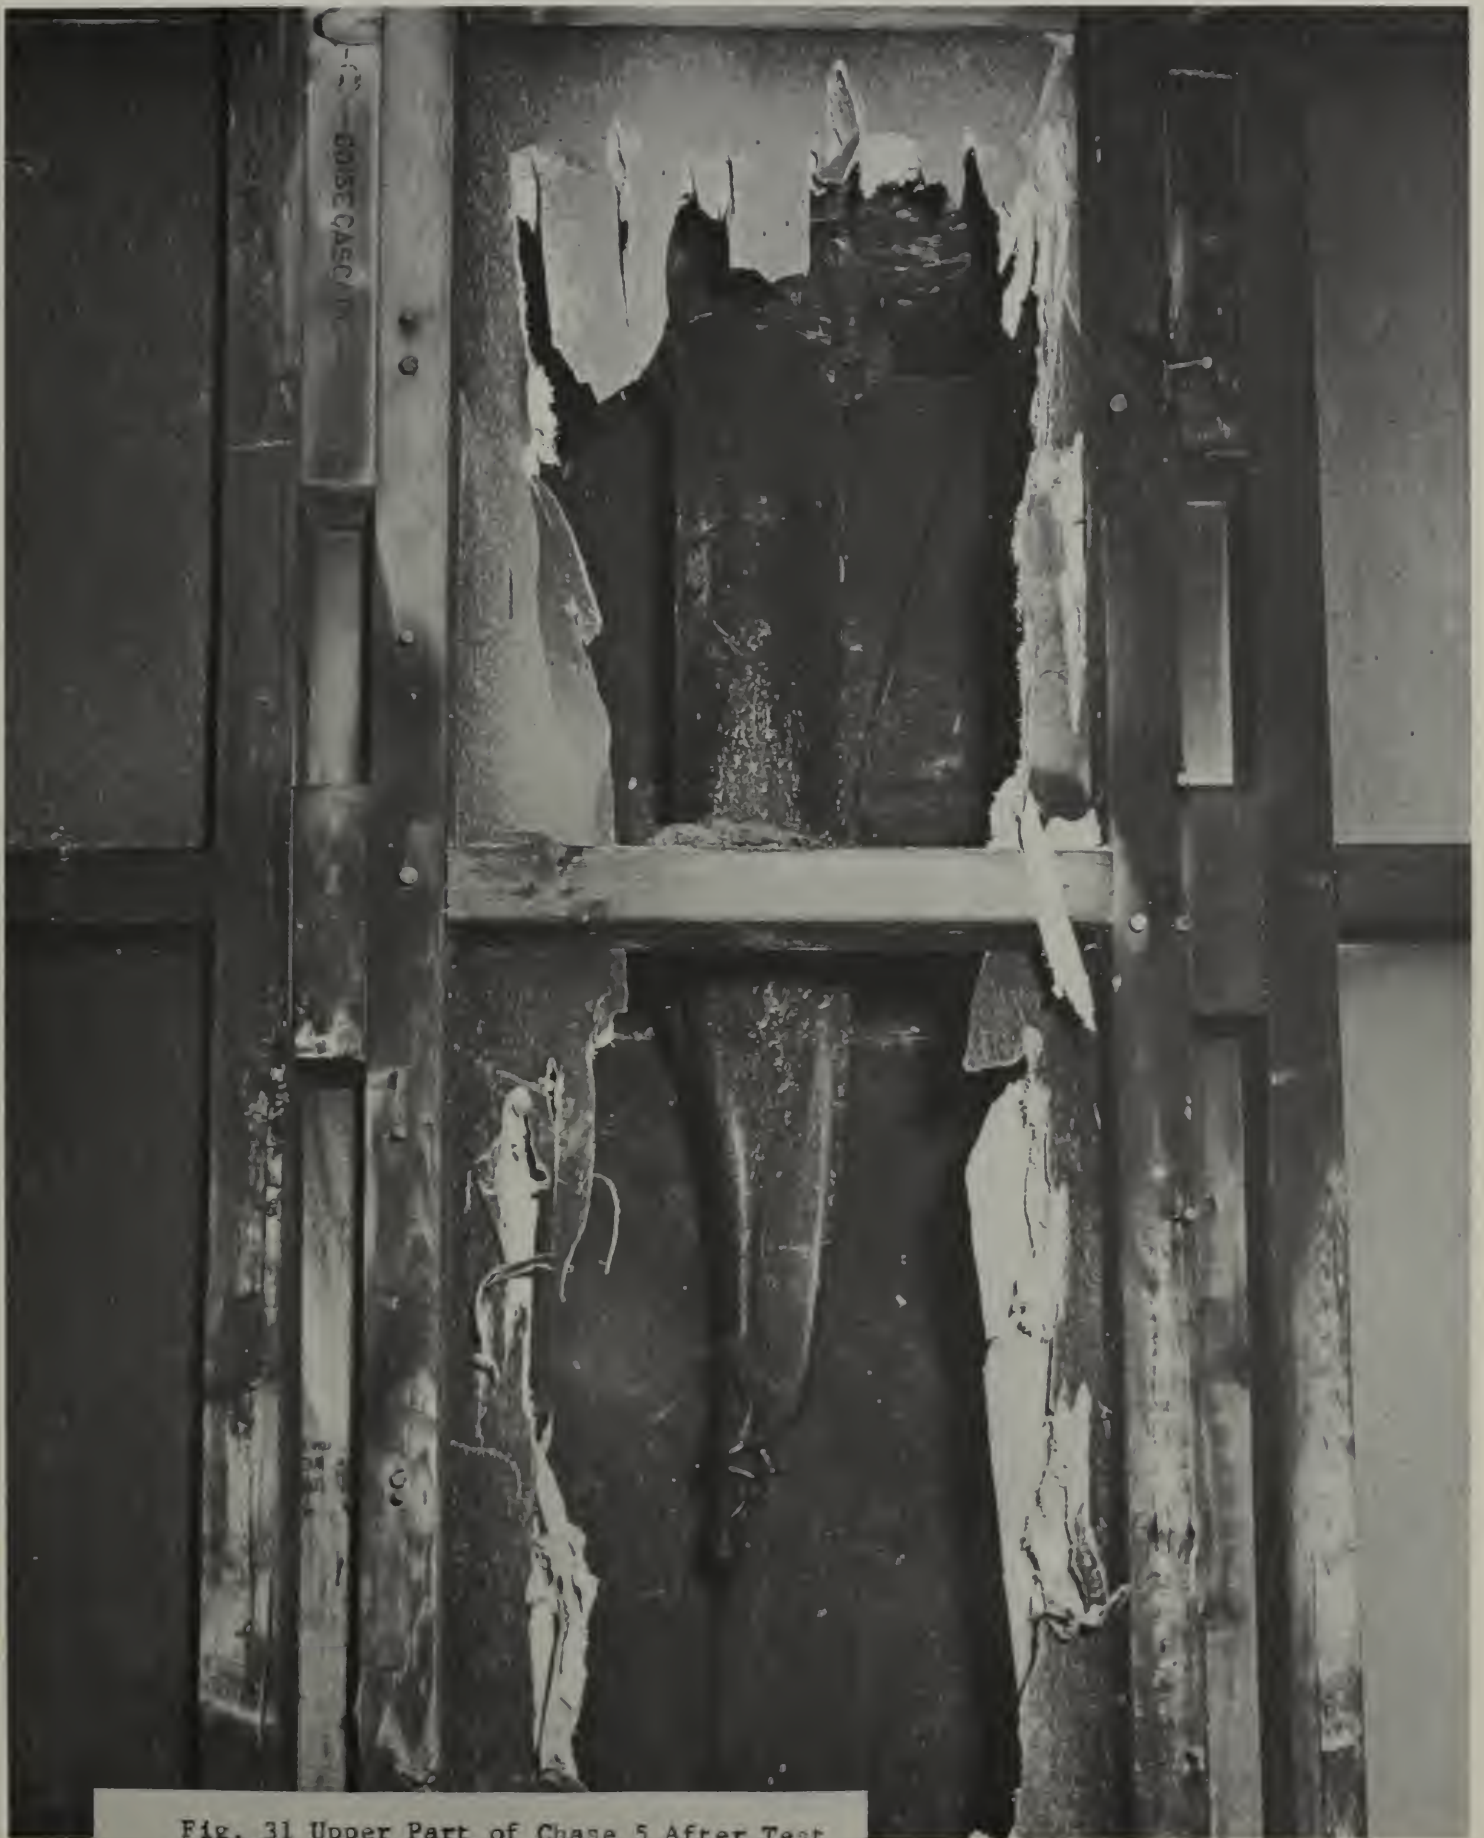
Fig. 31 Upper Part of Chase 5 After Test

The top of chase 5 can be seen from the furnace side in figure 31. The gypsum board was broken away after the test in order to view the pipe. There was about 1/3 of a cubic foot of pipe remaining as melted material at the bottom of chases 5 and 8 and none at the bottom of chases 6 and 7. The upper stack restrainers softened and separated in chases 5 and 8. The unexposed side of chases 7, 5 and 8 are shown in figure 32 with the burned out holes visible in chase 7.
